KINHILL PTY LTD
SLOPE STABILITY ASSESSMENT
ST PETERS URBAN WETLAND

A3256/1-AF
14 December 2000

**RE: SLOPE STABILITY ASSESSMENT
ST PETERS URBAN WETLAND**

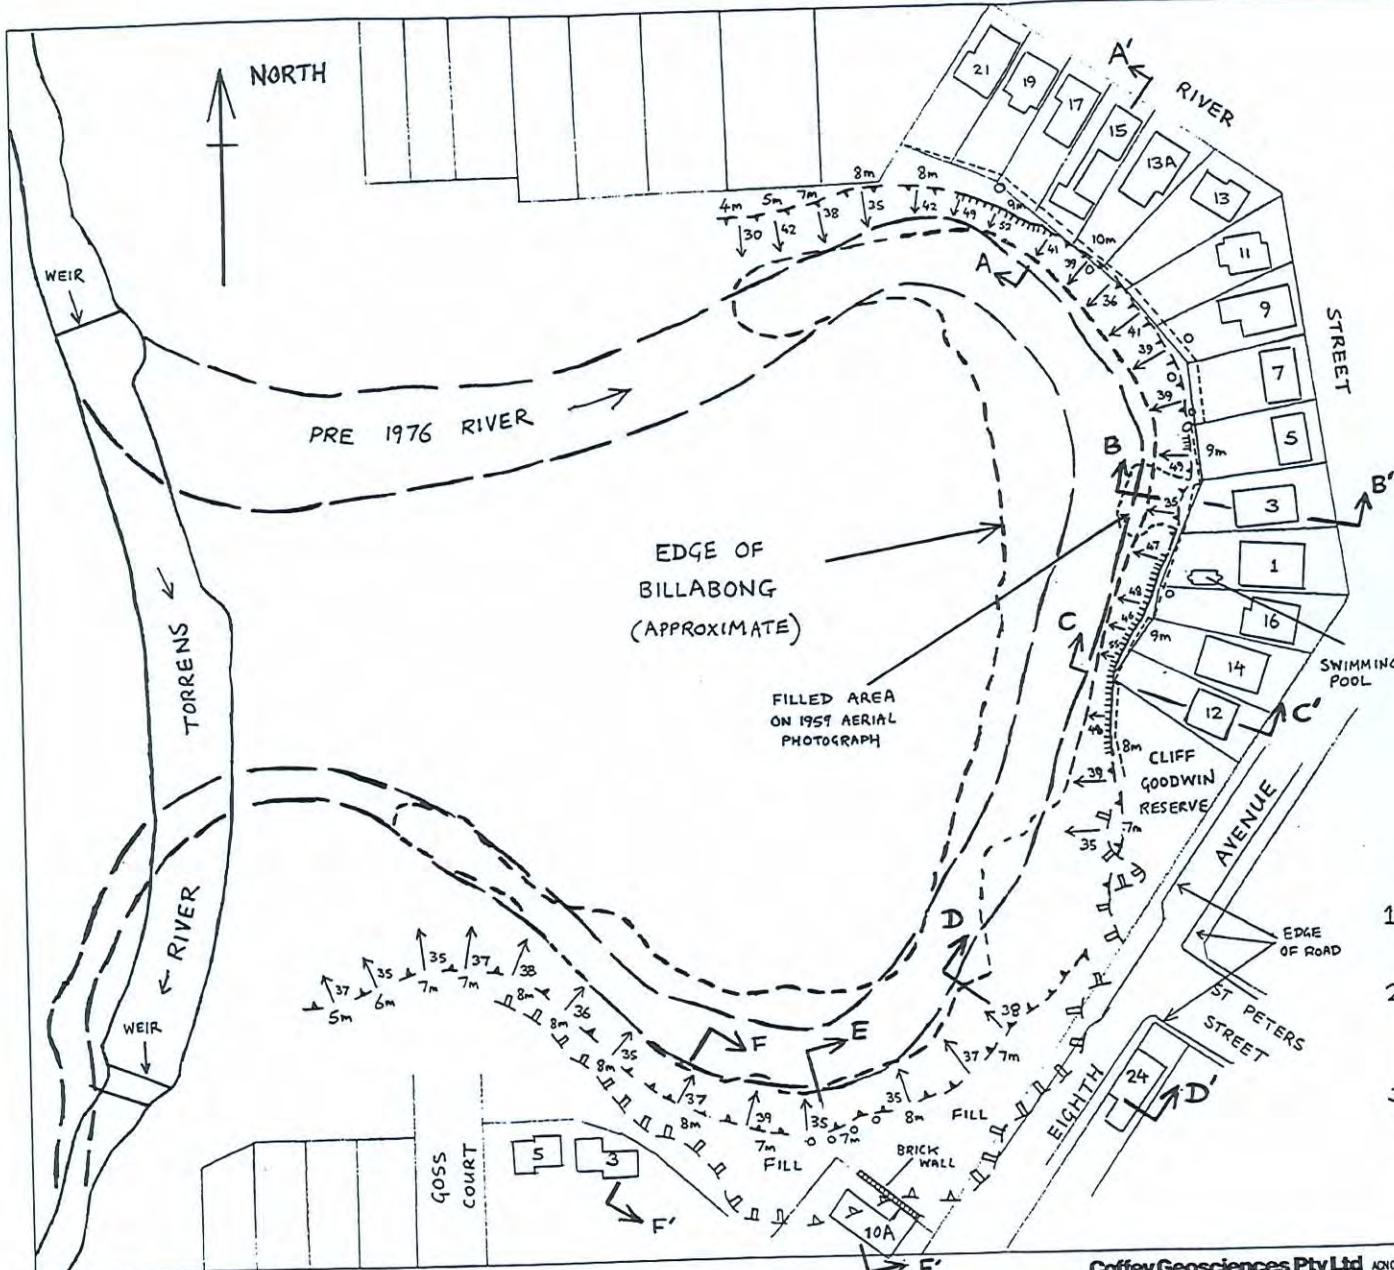
Figure 1 is a plan of the site. Cross sections of the old river bank overlooking the Billabong are shown in Figures 2 and 3. Figures 4 and 5 are photographs of the soil cliffs.

On Figure 1 we have shown the approximate position of the river bank near the Billabong where it is at least 5 m high. We have shown the slope height, and average slope and those sections of slope where soil cliffs occur. The soil cliffs are up to about 4 m high, are very steep and occur near the top of the river bank. Average overall slopes of up to 55° were observed where soil cliffs occur.

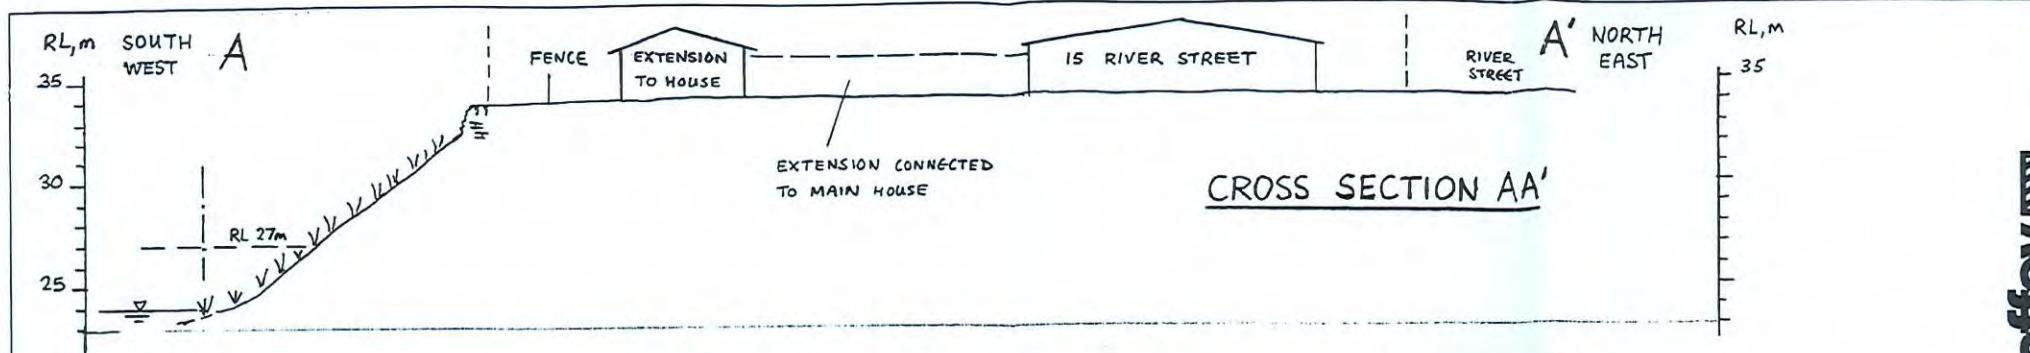
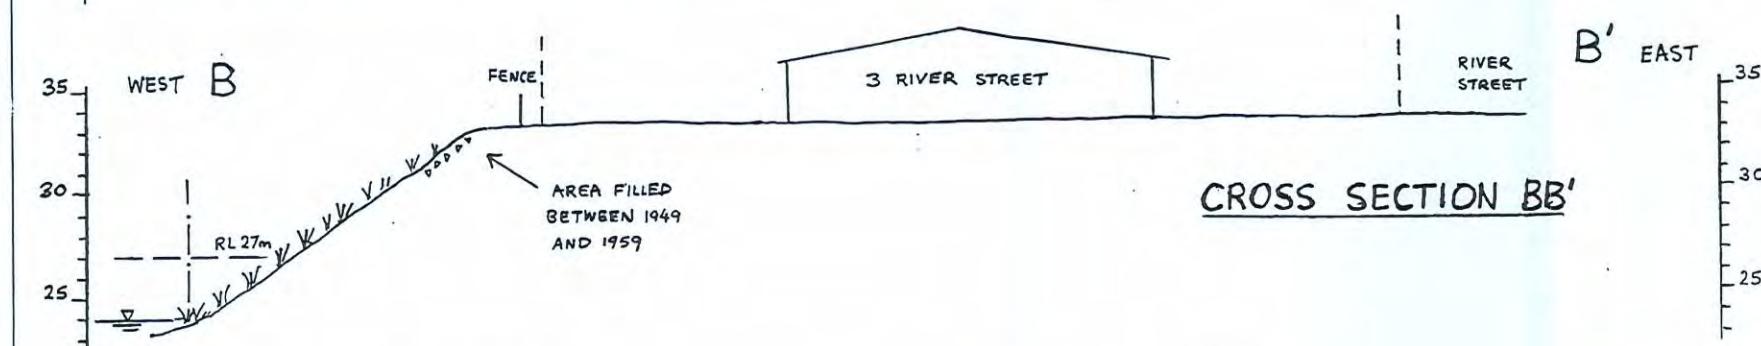
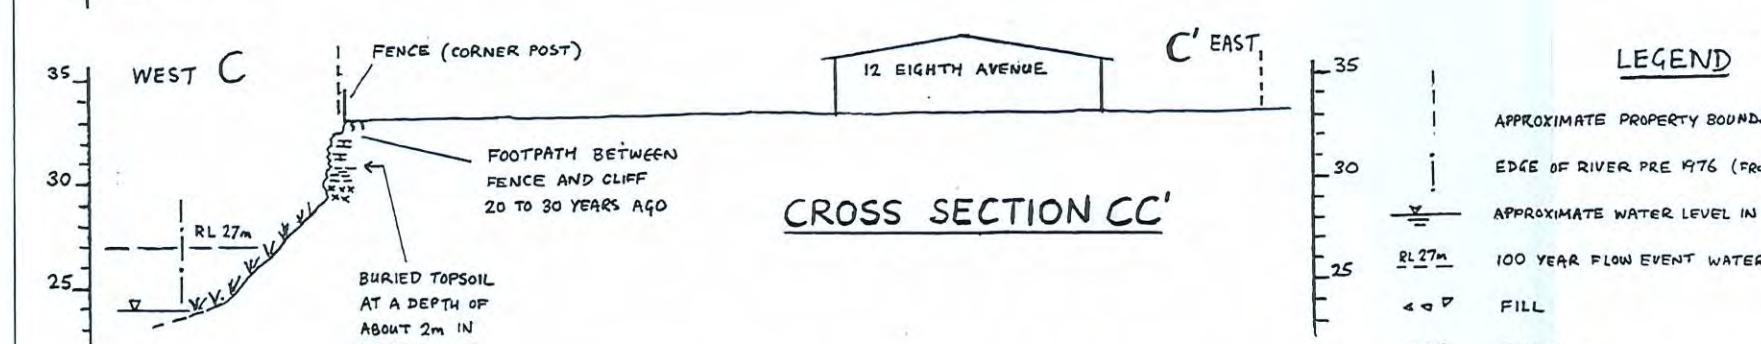
Scale (metres)							Drawing no: Figure 2 Job no: A3256/1

With this option there is likely to be erosion and small rapid drawdown failures which may increase the likelihood of overall slope failures. As shown on Figures 2 and 3 the 100 year flow level is well below the top of the slope and the soil cliffs. Unless significant undercutting occurs erosion and rapid drawdown failures are unlikely to have an effect on the rate of retreat of the soil cliff. The amount of erosion and failures that occur will be related to the rate at which water flows into and out of the Billabong.

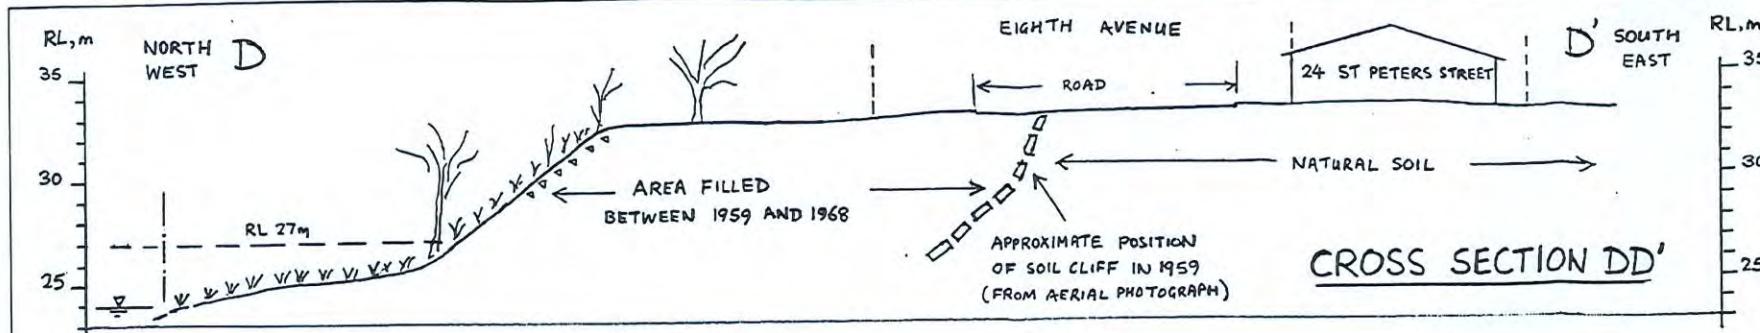
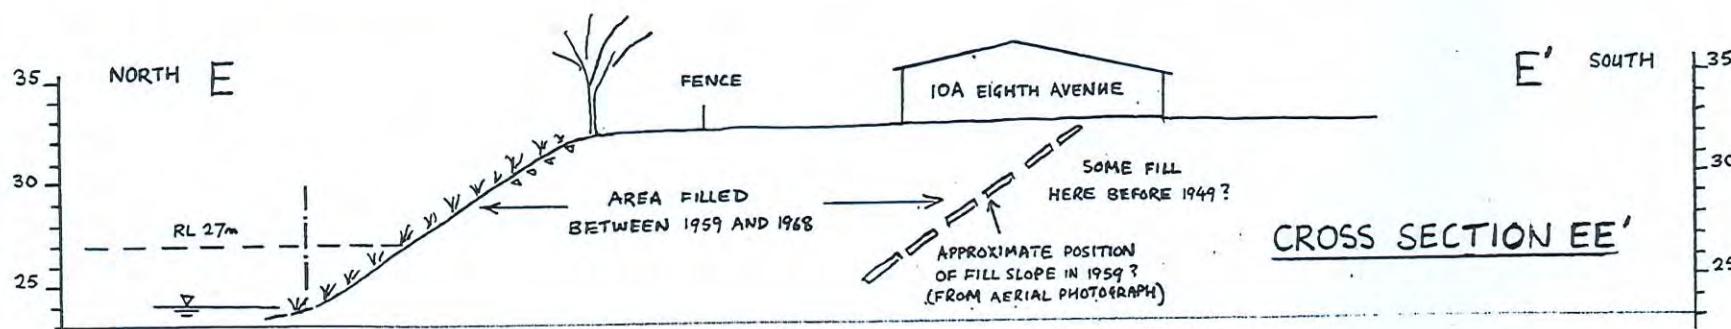
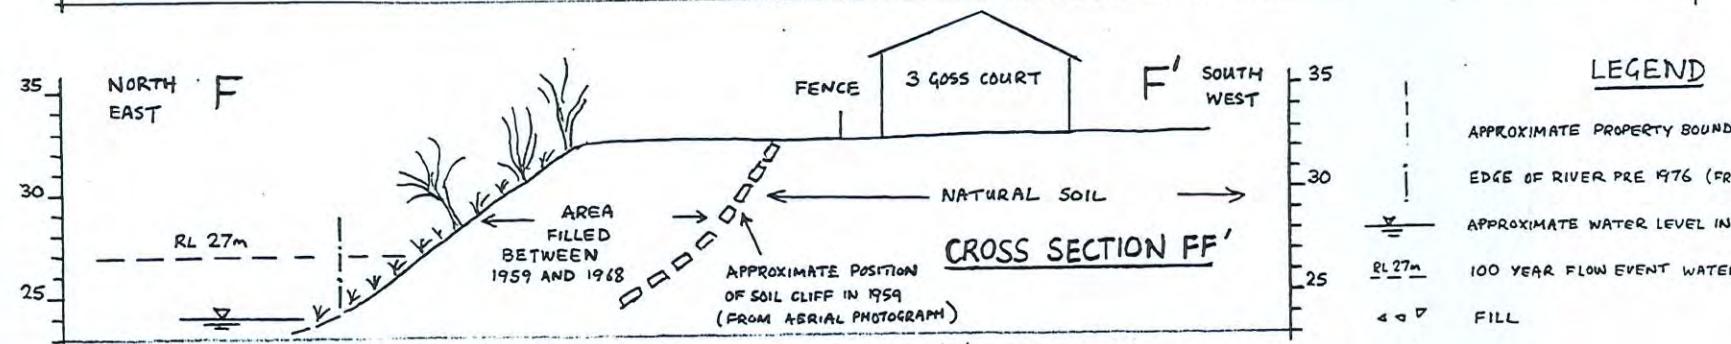
Scale (metres)	Revision	Description	Drawn	Approved	Date	Drawn	ATM	KINHILL PTY LTD ST PETERS URBAN WETLAND CROSS SECTIONS DD', EE' AND FF'			Drawing no: Figure 3
								Checked	ATM	Date	
0 5 10 15										23 Jun 2000	Job no: A3256/1

Part of Eight Avenue (Figure 1 and Figure 3, Section DD') may be founded on fill near an old soil cliff and may be vulnerable to differential settlement.

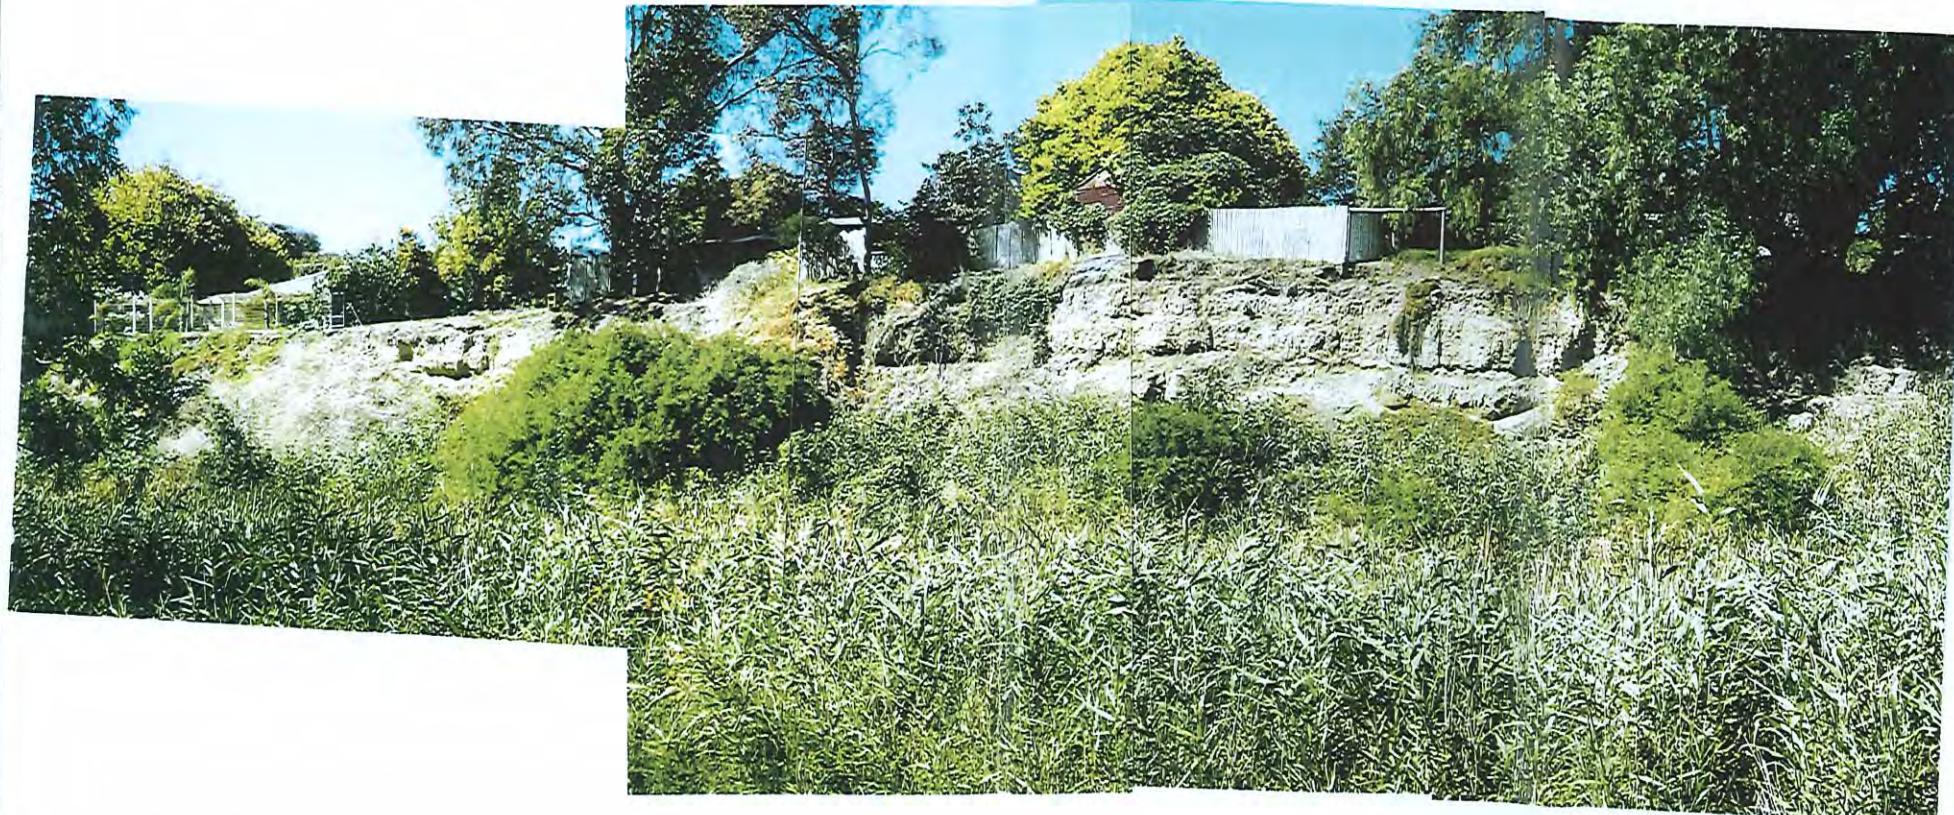
At the time of the site mapping the southern corner fence post at the rear of Number 12 Eighth Avenue was located at the top of the soil cliff (Figure 5). The residents of the house reported that there used to be a path behind their fence and "about 10 years ago" children could get around the corner. Most of the recent erosion appears to have been of the friable topsoil. The underlying variably cemented calcareous soil still extends beyond the fence (Section CC' Figure 2). The residents understand that many years ago (before they lived there) there may have been a wider track behind the property with enough room for a horse and cart. Older residents in the area may have knowledge of this path or track.

As discussed above there has been loss of material from the soil cliffs overlooking the Billabong in recent years. This has probably been the result of erosion and small slope failures (toppling failures on near vertical joints). Erosion has probably been caused by rain, wind, animal burrowing, and the action of plants (growing roots dislodging soil). Human activity may have also contributed to the erosion (eg, disturbed topsoil on narrow footpaths or climbing across the cliff face). In places the soil cliff is undercut (Section CC' on Figure 2) and there are near vertical open joints or tension cracks. In other places the soil mass in the cliff appears to be bound together by tree roots and the cementing (particularly in the calcareous soil) contributes to the stability of the cliffs.

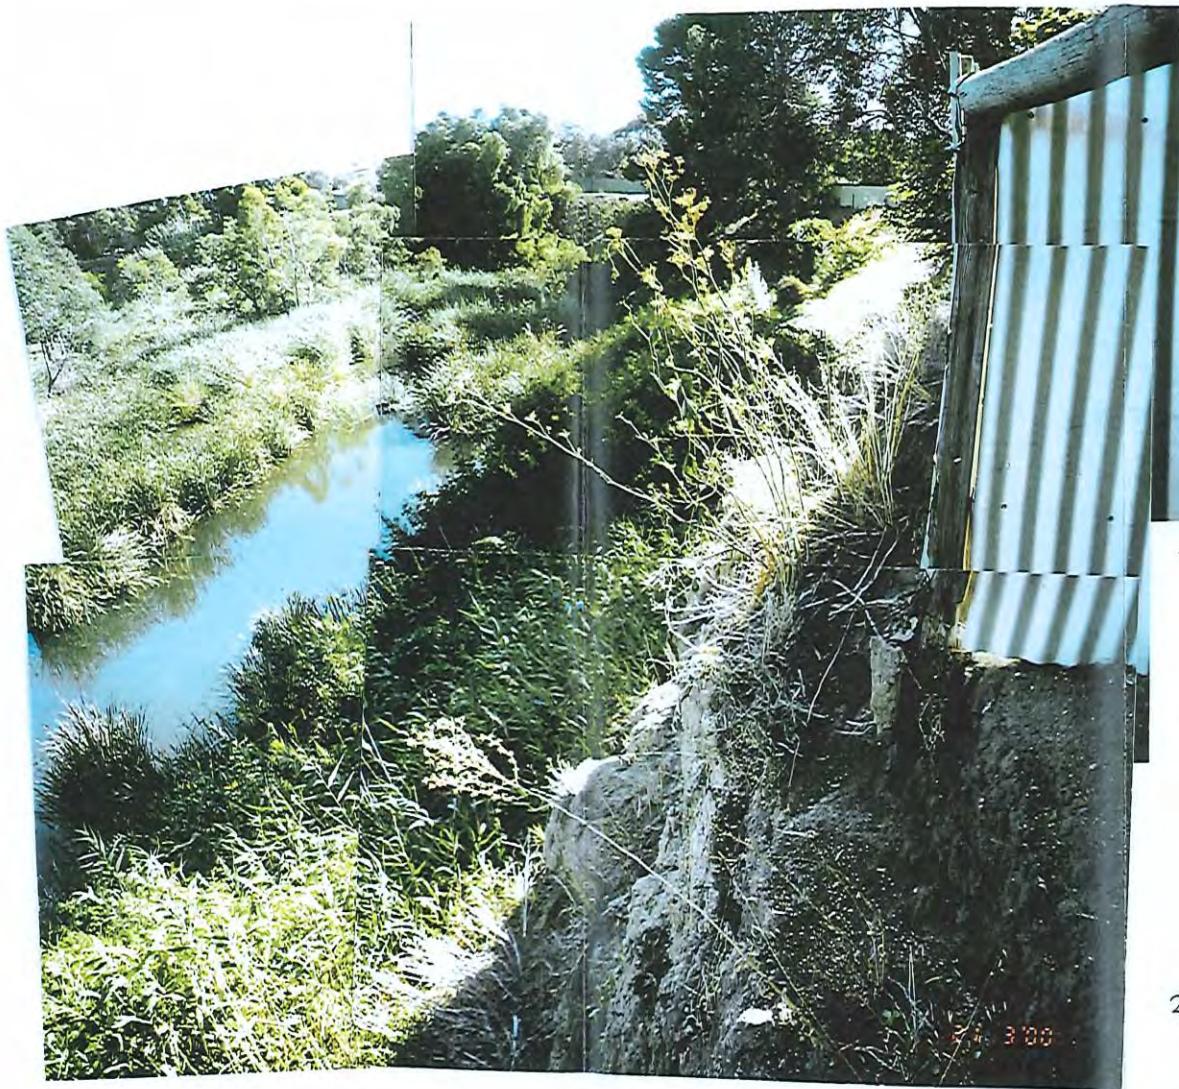
Property	Comments
12 Eighth Avenue	Most vulnerable property. Fence at top of the soil cliff (Figures 1, 3, 4 and 5).
14 and 16 Eighth Avenue	Properties with fences within about 2 m of the top of the soil cliff or slope
1, 3, 5, 13 and 13A River Street	(Figures 1, 2 and 5).
7, 9, 11, 15 and 17 River Street	Properties with fences between about 2 m and 10 m of the top of the soil cliff or slope (Figures 1 and 2).
